GREETINGS

THE BUSH TRAMWAY CLUB INC.

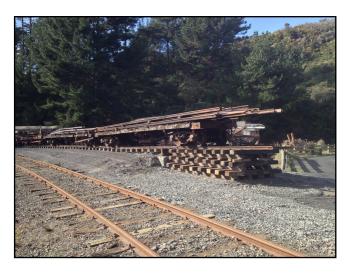
MOTAT BODS AT THE JUNCTION:

What an amazing job they have done to our overgrown triangle area. They originally applied to us for all our 70lb rail and fittings and to build a ramp to cut down on the cost of returning our Cb to us.

All told, they spent 3 ½ weeks at the Junction. They have cleared the whole of the triangle area, dismantled the stack of tracksets that were buried in the scrub, constructed the ramp and taken away most of our 70lb track and fittings.

The 70lb tracksets all needed dismantling before the rails and point parts could be loaded onto our flat top wagon and then transferred to a couple of trucks.

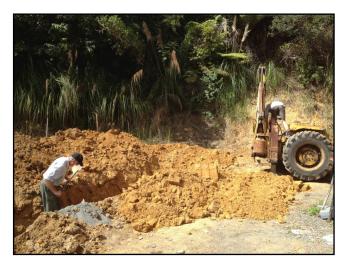
NEW SHED BEHIND THE Woodwork Shop:

Our battery electric group have done a lot of the earthworks for the siding into this new shed. But there is more still to be done. They have purchased the kitset shed that will be 9.8 meters long. When they get more money, they will purchase the rest of the shed.

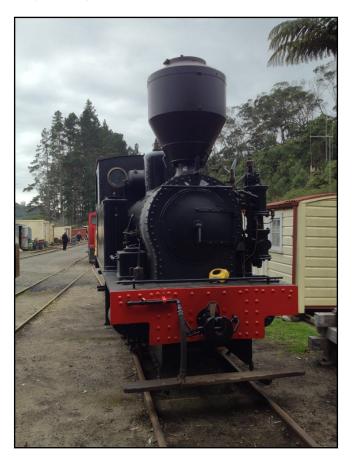
РЕСКЕТТ 1650:

The loco was tried on the passenger train for the first two trips during the May open day but had to come off because the valve timing was way out.

On Sunday 9/6, Chris came down and when the rain stopped, put the Peckett over the pit. Neil had taken the valve chest covers off the weekend before. He adjusted the left hand side valve, the lock nut had come off the valve spindle, the nut had backed off and there was approx. 1½" movement of the valve on the spindle. That would explain why the valve timing seemed to be getting worse.

A number of steam leaks to the Westinghouse air compressor have been attended to.

He hoped to come down during our working bee on 23/6 and try the loco out.

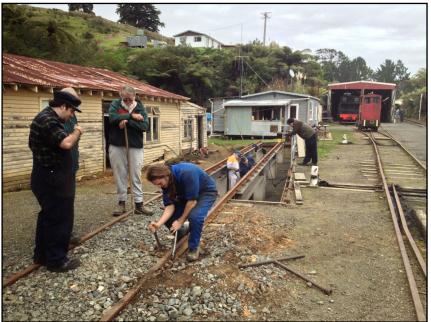
Here we have several people working on the pit during the June Open Day. The rail being worked on in the foreground had been lifted into position and is in the process of being fastened back onto the sleepers, pit plates, and reconnected to the rail before it. In the background is Ian and a welder working on the pit beams, with Ashley keeping an eye on them. Way down the back you can also see the Peckett, being worked on as seen in the picture on the front page.
